September 1966 THE NAVAL AVIATION SAFETY REVIEW

Emergency Abort

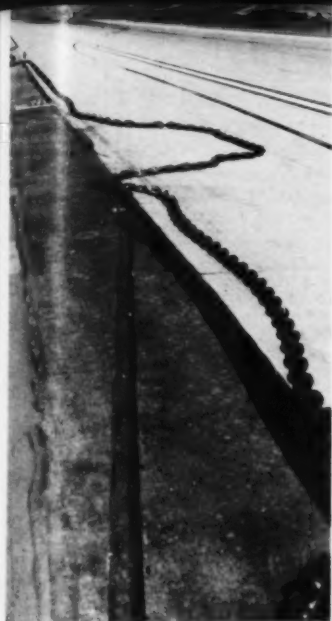
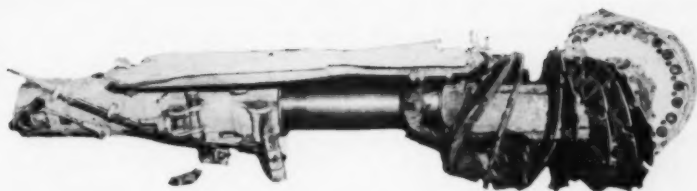
The starboard strut sheared as it passed over the chain. Burning JP-5 trailing, enveloped the F-4B as it slid to a halt.

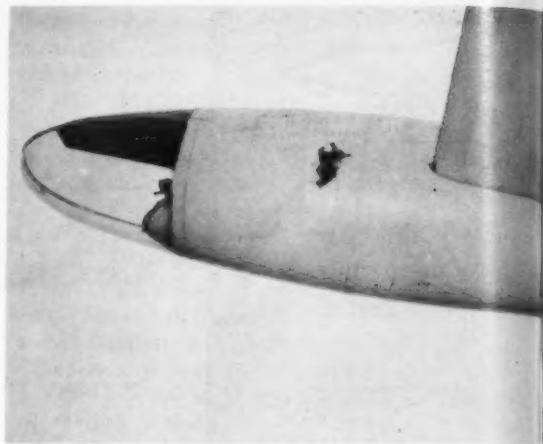
During the second full flap touch-and-go landing, and immediately after application of max power on the recips and 100 percent RPM on both jets, the radioman heard an explosion on the starboard side of the aircraft and observed heavy smoke and flames being emitted from an area outboard of the

starboard reciprocating engine. He immediately notified the pilot via the ICS, stating that he saw "fire in the starboard engine." The copilot also heard the explosion, and, moments later, noticed the starboard jet fire warning light ON. *Assuming that the pilot had seen the fire warning light, the copilot did not report the indication via the ICS.* Airspeed at this point was approximately 100-105 kts, with about 4000 ft of runway remaining.

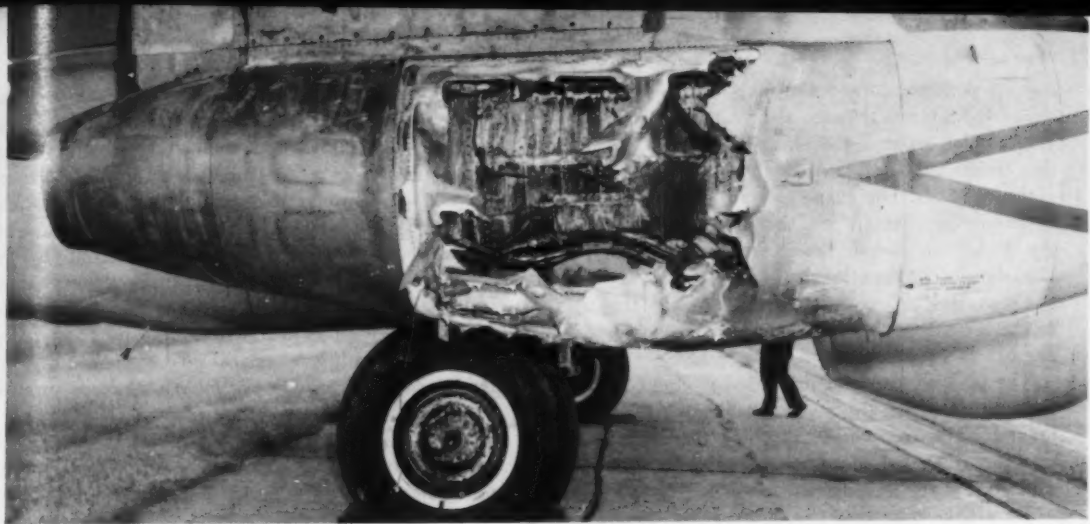
The radioman reported on the ICS that the starboard jet was still burning, and sent the second mech to the afterstation for a more accurate observation of the situation. Due to a faulty headset in the after-

The primary cause of this flight incident, unknown to the crew at the time, was the disintegration of the second stage compressor rotor of the starboard jet engine, which led to complete failure of the engine and started the ensuing fire.

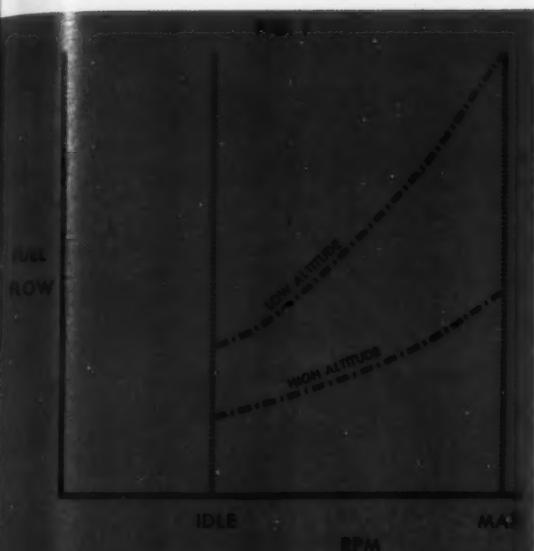
FIG. 2

Figure 2 illustrates why the expensive components of a fuel control are required. The solid line again represents the fuel flow required to run at a given RPM for one set of conditions. Any fuel flow greater than this amount will cause the engine to accelerate and any fuel flow less than this amount will cause the engine to decelerate. The crosshatched areas on the chart are "prohibited" combinations of fuel flow and RPM for these conditions. Operating in the upper region will cause the engine to stall or chug. The reason for this is that the high combustion temperatures caused by the excessive amount of fuel raises the pressures in the aft sections of the engine. This increase in pressure raises the pressure ratio across the compressor resulting in a lowering of air velocity within the compressor.

For an axial flow engine lower air velocities mean higher angle of attack for each blade. The blade will stall if the angle of attack becomes too high in the same way that the wing on an aircraft will stall. This causes a further reduction in air velocity through the engine (equivalent to loss of lift of a wing) and

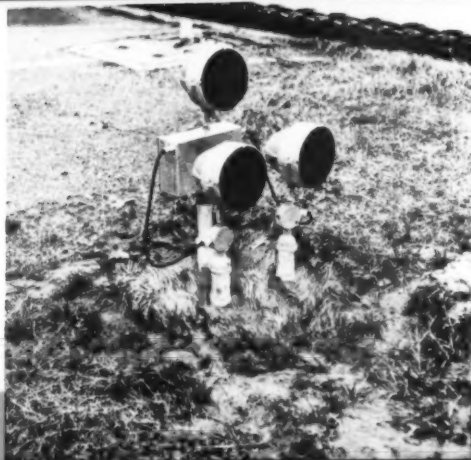
Frangible-mounted light cluster . . .

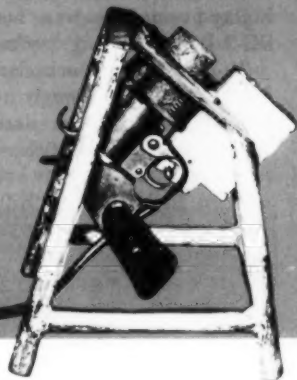
Remote-controlled flaregun.

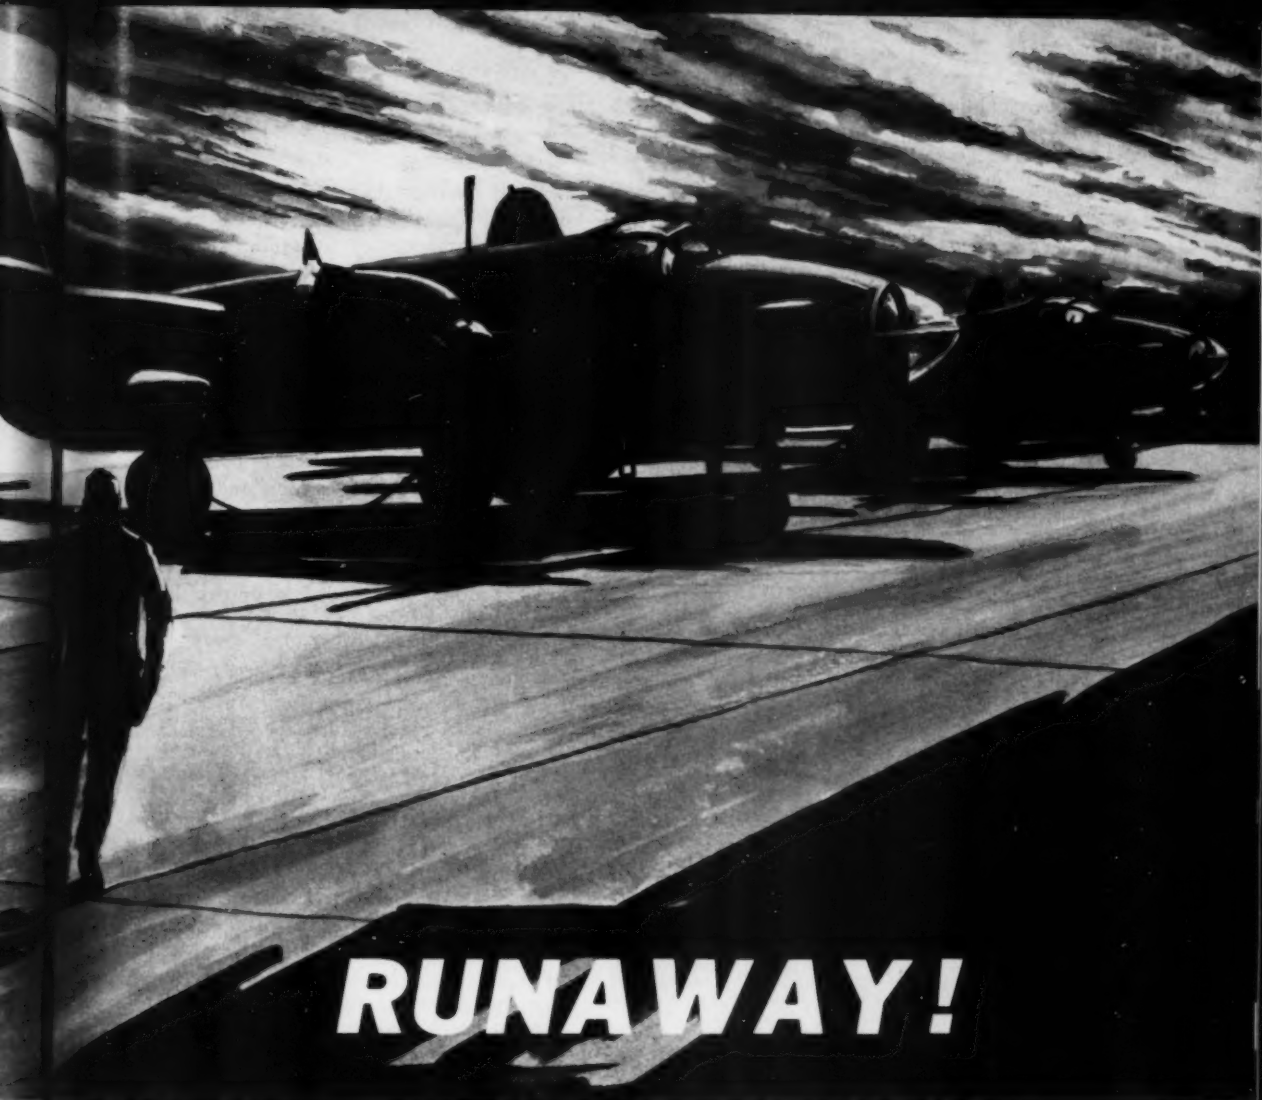
RUNAWAY!

The chain of events had begun innocently enough. At 1430 that afternoon BuNo 123456 had returned from a four-hour training flight. After the engines were shut down, the plane was spotted on the back line and the parking brakes were set by the plane captain, who noted that the emergency hydraulic system pressure returned to normal after the brake was set. The aircraft was then chocked and tied down

Panel, and placed the Emergency Hydraulic System Control circuit breaker in the off position. It was then determined that the Main Hydraulic System Accumulator was at fault, having developed an internal leak. At the direction of the shop supervisor one of the men removed the accumulator and then capped off the hydraulic line (fingertight) that led to it.

Closer supervision was needed at this point. The airframes shop supervisor did not insure that the aircraft had been left in a safe condition, to wit, chocked, tied down and placarded. Later on that afternoon, he turned over an incompleted job (on Buno 123456) to the night crew without actually having checked the work that had been accomplished.

2200 rpm and 34" MAP was reached, and then it jumped the chocks. These chocks had worn edges and were fitted tightly under the wheels. In another test, these same chocks were placed about 4 inches in front of the wheels to simulate a sloppy placement. This time, the chocks held an unbraked aircraft until a power setting of 2100 rpm and 32" MAP was reached.

Two of the aircraft received Delta damage. The third received Charlie damage.

damage was comparatively light. Fortunately, the engine and fuel cell areas of the three damaged aircraft were unscathed. Had they been damaged during one of the collisions, a fuel fire might have erupted, causing a far more serious, and possibly tragic, outcome.

- The aircraft was not red-tagged to indicate an inoperative hydraulic system.
- Improper job turnover—Maintenance Control did not coordinate shop efforts.
- Failure to use NATOPS checklists for preflight and turnup.
- Improper chocking of wheels and tie-down.

- Always placard an aircraft whenever a system is incapacitated.
- Pass the word, in writing, on job turnover. Remember, two-way communications within the maintenance department is necessary for flow of information up and down the chain to keep Maintenance Control informed of work in progress.
- Preflight for turnups—use the NATOPS checklist.

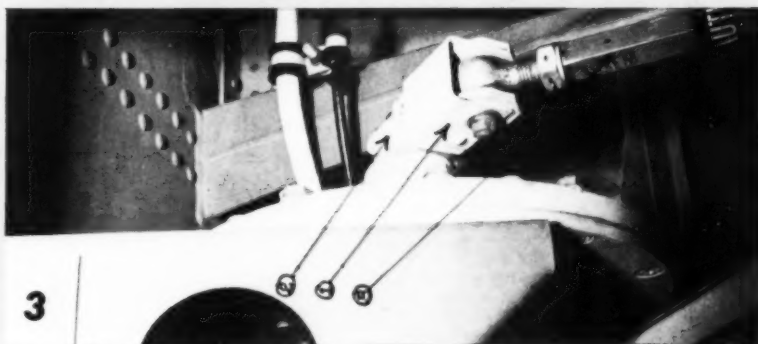
A routine calendar inspection disclosed that the upper rubber viscous damper arm assembly (PN 834197-3) had been installed 180 degrees out of proper position. See photo 1. Rudder forces then caused the upper push rod (PN 923069-1) to break the guard plate (PN 908914-11). See photo 2. Improper rigging of the upper and lower viscous dampers caused binding. This Murphy was detected during the fourth calendar inspection since Navy acceptance, and the first since squadron acceptance. Although there is a requirement for examination of this assembly during each calendar inspection, the original installation is suspected of being faulty because the paint had not been disturbed.

Photo 1: Rudder, full right. Arm (3) installed 180 degrees from normal position allowing viscous damper arm (2) to break guard plate (1). Photo 2: At full left rudder, damper arm (2) forced its way through guard plate. Photo 3: Arm (3) correctly installed. Viscous damper arm (2) cannot make contact with guard plate (1).

* If an aircraft part can be installed incorrectly, someone will install it that way!
